Use Attainability Analysis

WBID 1265 East Creek

Submitted by SES Inc.

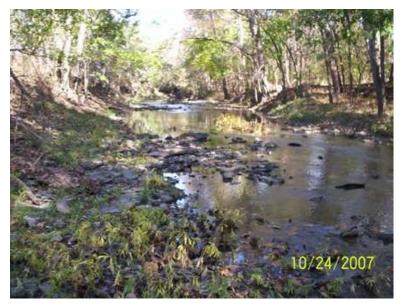
Site# 1 Photo ID# 10, Upstream

Evidence of Human Use:  Roads   Foot path/prints   Dock/platform   Camping Sites   Rope swings   RV/ATV Tracks   Fire pit/ring   NPDES Discharge   Fishing Tackle   Livestock watering comments/other: none  Substrate: % Cobble   Gravel   Sand   Silt   Mud/Clay   Bedrock 70   30    Aquatic Vegatation: none  Water Characteristics: Odor:   Sewage   Musky   Chemical   None   Other: Color:   Green   Gray   Milky   Other: Murky   Bottom Deposit:   Sludge   Solids   Fine sediments   None   Other: Murky   Bottom Deposit:   Sludge   Solids   Fine sediments   None   Other:	□ Boating accesses	☑ Fence	☐ No tresspass sig	n 🗆	J Steep Slopes	☐ Other:	
Evidence of Human Use:  Roads							
□ Roads □ Foot path/prints □ Dock/platform □ Camping Sites □ Rope swings   □ RV/ATV Tracks □ Fire pit/ring □ NPDES Discharge □ Fishing Tackle □ Livestock watering   Substrate:   % Cobble % Gravel 70 % Sand 8 Silt % Mud/Clay 30 % Bedrock   Aquatic Vegatation:   none Water Characteristics:   Odor: □ Sewage □ Musky □ Chemical ☑ None □ Other:   Color: □ Clear □ Green □ Gray □ Milky ☑ Other:   Murky Bottom Deposit: □ Sludge □ Solids □ Fine sediments ☑ None □ Other:	none

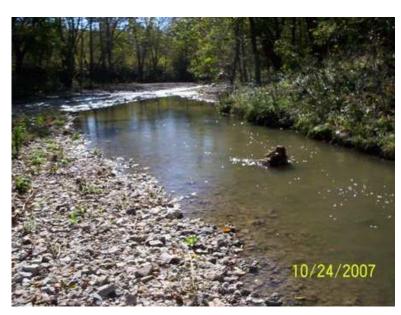
Site# 2 Photo ID# 12, Downstream

-						
Substrate:						
% Cobble	% Gravel	% Sand	% Silt	% Mud/	Clay % I	Bedrock
50	50					
Aquatic Vegatation:	<u>:</u>					
none						
Water Characteristi	ioo					
Odor:	□ Sewage	☐ Musky	☐ Chemic	ical 🗸	None	Other:
Color:	☐ Sewage	□Green	☐ Gray			Other:
Coloi.	LI CIGAI	ПОІССІІ	L Clay		•	ırky
Bottom Deposit:	☐ Sludge	☐ Solids	☐ Fine se	ediments 🗸		Other:
Surface Deposit:	□ Oil	☐ Scum	☐ Foam			Other:

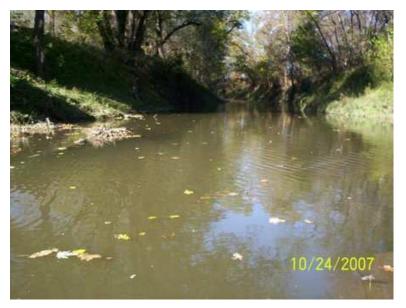
Site# 3 Photo ID# 16, Downstream

0						
Surrounding Condition  ☐ City/County parks	ions: □ playgrounds	☐ MDC conserv	etion lands	☐ Urban areas	☑ Rural R	esidential
☐ Campgrounds	☐ State parks	□ National Fore		☐ Nature trails	☐ Stairs/v	
	☐ State parks				☐ Other:	Vaikways
☐ Boating accesses	LI Ferice	☐ No tresspass	sign	☐ Steep Slopes	U Other.	
Comments:						
none						
Evidence of Human l	Use:					
□ Roads	☐ Foot path/prints	☐ Dock/platform		☐ Camping Sites	s ☑ Rope s	wings
☐ RV/ATV Tracks	☐ Fire pit/ring	☐ NPDES Discha				ck watering
comments/other:		1				<u>-</u>
none						
i						
i						
<u> </u>						
Substrate:						
% Cobble	% Gravel	% Sand	% Silt	% Mud/	/Clay	% Bedrock
	40	, , , , , , , , , , , , , , , , , , , ,		60	•	/ <del>* -</del> -
Aquatic Vegatation:						
none

110.10						
i						
i						
<u> </u>						
Water Characteristics	;s:					
Odor:	☐ Sewage	□ Musky	□ Chemi	ical 🔣	None	☐ Other:
Color:	☐ Clear	□Green	☐ Gray		Milky	Other:

-		<u> </u>	Murky
Bottom Deposit:	☐ Sludge	☐ Solids	☐ Fine s	sediments 🗹	None	☐ Other:
Surface Deposit:	□ Oil	☐ Scum	☐ Foam		None	☐ Other:

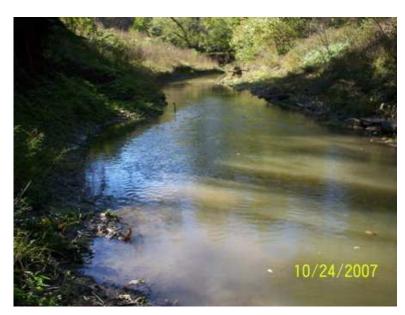
Site# 4 Photo ID# 14, Downstream

Surrounding Conditi	ions:				
☐ City/County parks	☐ playgrounds	☐ MDC conservati	ion lands 🔲 Urbai	n areas 🛛	Rural Residential
☐ Campgrounds	☐ State parks	□ National Forests	s □ Nature	e trails	Stairs/walkways
☐ Boating accesses	✓ Fence	☐ No tresspass sig	gn □ Steep	Slopes □	Other:
Comments:					
none					
Evidence of Human	IIaa.				
		Designations	I Comr	' O'400   F	December and and
☐ Roads	☐ Foot path/prints	☐ Dock/platform			Rope swings
☐ RV/ATV Tracks	☐ Fire pit/ring	☐ NPDES Discharg	je  ⊔ Fisiiiii	ng Tackle □	Livestock watering
comments/other:	none				
<u> </u>					
Substrate:					
% Cobble	% Gravel	% Sand	% Silt	% Mud/Clay	y % Bedrock
,	20	70 33.13.	30	50	,
<b>Aquatic Vegatation:</b>					
none					
Water Characteristic					
Odor:	□ Sewage	☐ Musky	☐ Chemical	✓ Non	
Color:	☐ Clear	□Green	☐ Gray	☐ Milk	ky ☑ Other:
	LI CIEAI				
			Í		Murky
Bottom Deposit:	☐ Sludge	☐ Solids	☐ Fine sediments	s ☑ Non	ne 🗆 Other:
